**EVALUATION OF FUTURE FUELS IN A HIGH
PRESSURE COMMON RAIL SYSTEM – PART 2
2011 FORD 6.7L DIESEL ENGINE**

**INTERIM REPORT
TFLRF No. 434**

**U.S. Army TARDEC Fuels and Lubricants Research Facility
Southwest Research Institute® (SwRI®)
San Antonio, TX**

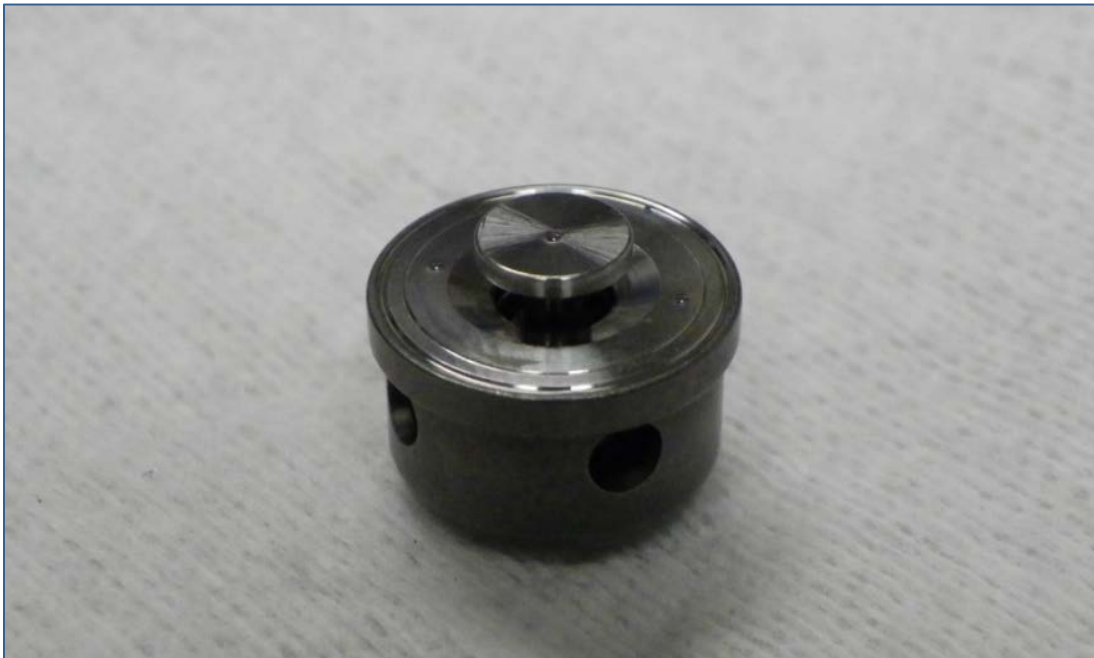
Figure 29. Inlet Check Valve

The inlet check valve is a component which, if failure occurs, can prevent the pump from properly developing rail pressure. The two major failure modes are for the valve to stick closed and no longer open, or fail open in a way that prevents it from properly sealing. If failing closed, fuel will be unable to fill the pump head chamber and therefore no additional fuel will be supplied to the rail. In this case, the injectors will rapidly drain the remaining high pressure fuel supply to the point of system fault codes invoking an engine protection shutdown, or injectors failing to fire due to lack of actuation pressure. If failing open resulting in sealing failure, insufficient pressure will be developed in the pump head to overcome to rail pressure on the downstream side of the outlet check valve. Fuel will be forced back through the inlet valve into the pump body. Again, pressure in the rail will decrease until the injection process is stopped. The valve and seat area of the component is shown in Figure 29. The small dimple marks visible are from post-test measurements that were taken, not from operation.

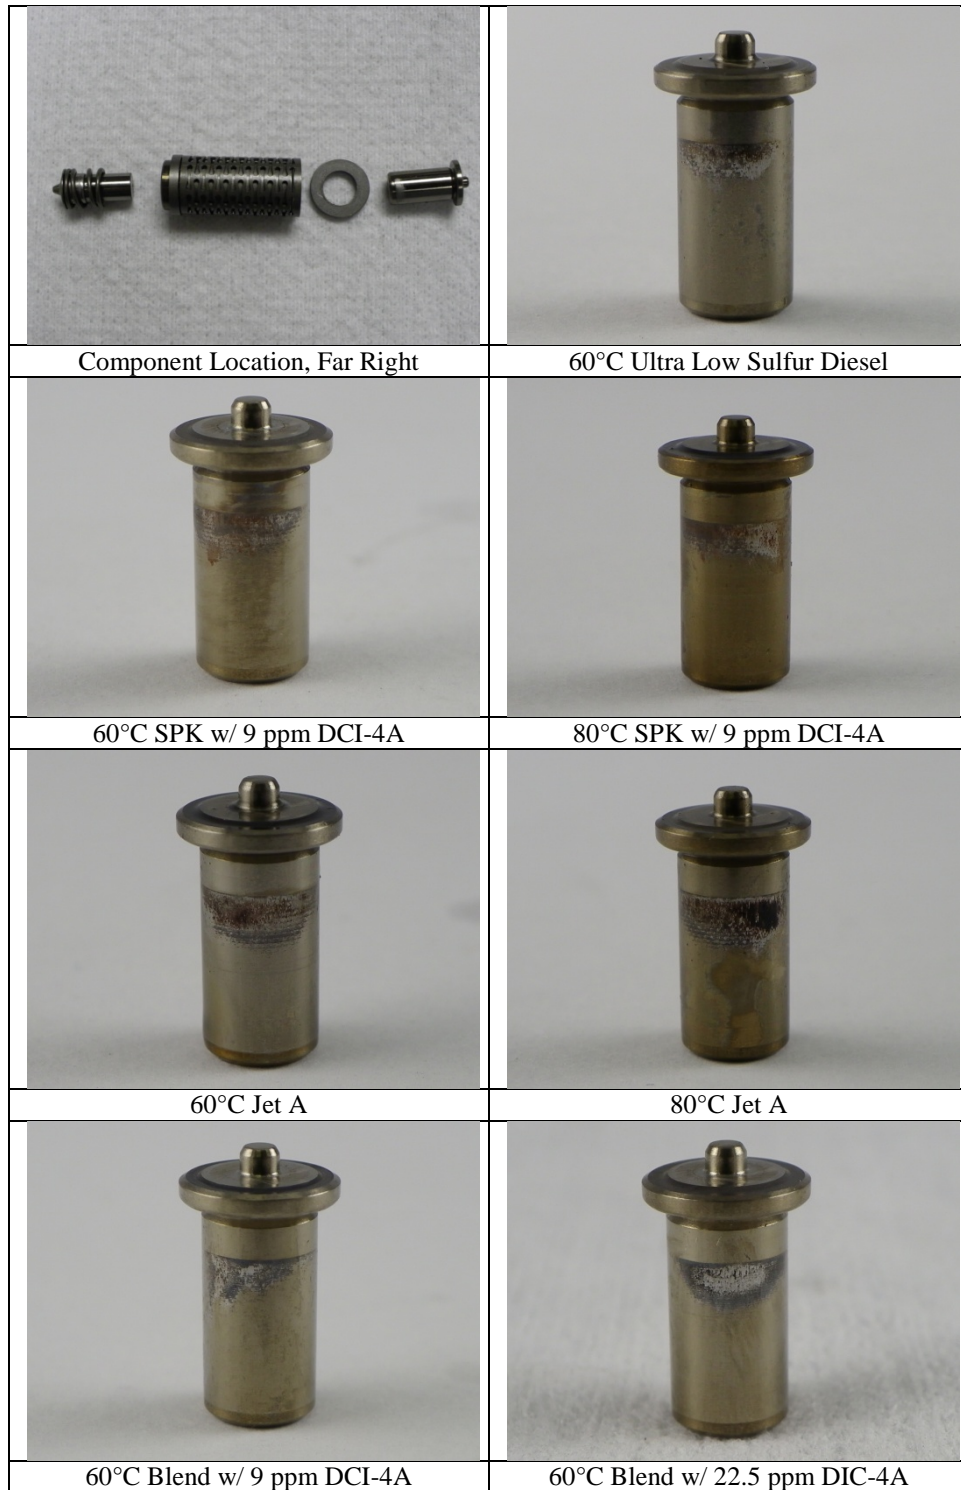
Figure 43. Upper Hydraulic Coupler Piston, Site A

At the other end of the coupler is the upper piston which the piezo stack acts directly upon. This piston has a larger diameter than its lower counterpart to provide the linear motion amplification when the piezo stack is energized. A similar style of scar can be seen on the component in Figure 43 and Figure 44.

The upper component wear, on both sides, varied from the test to test but again did not seem to trend strongly with a fuel property. However, since the coupler is a critical component in the injector which could lead to a failure, and one of the few injector parts to have a visible wear scar, further quantitative methods were investigated to compare fuel impact. Guidelines from the CRC Distress Rating Manual 21 were used to evaluate the component from ULSD, 9 ppm Blend, and 80°C Jet A tests, representing a good, medium, and poor fuel based on lubricity. For each test, the component was removed from 7 of the 8 injectors. One injector was left intact and assembled in the event future inspection of an unhandled component was required. Merit ratings were given on a surface area percentage - rating basis for Site A, Site B and the remainder of the part (Site C). Results are presented in Table 4, Table 5, and Table 6.
